# Manhole Inspection Summary

Manhole # S53C\_\_057MH

**Location** Address: **31 n eastern ave** Cross Street: **e fairmount ave**

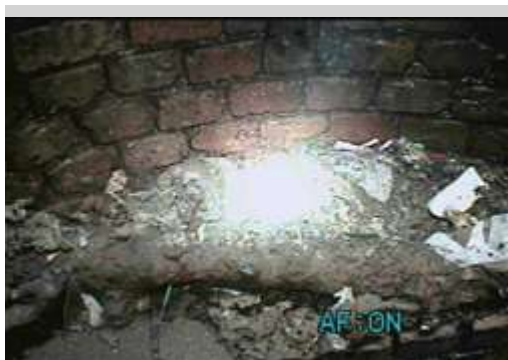
Defect 4

Condition: ☐ Sound ☐ Cracked ☐ Root Intrusion ☐ Deteriorated ☐ Leaks ☒ **Debris**

bench debris

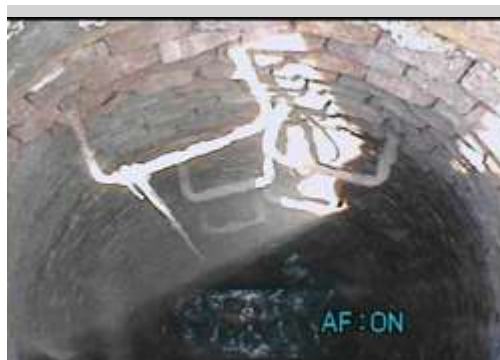
Defect 3

**Steps** Count: **7** Missing: **2** ☒ **Corroded**

steps

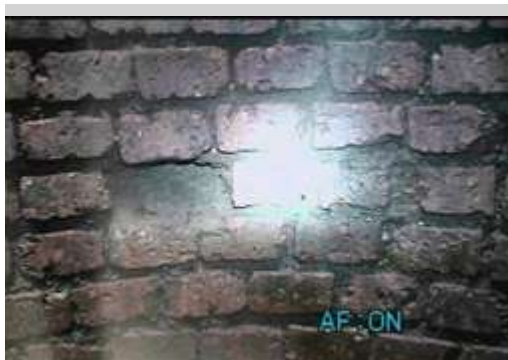
Defect 2

Condition: ☐ Sound ☐ Cracked ☐ Root Intrusion ☒ **Loose Brick** ☐ Deteriorated

missing brick in barrel

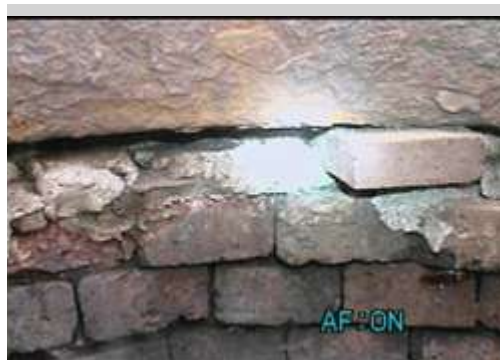
Defect 1

Condition: ☐ Sound ☐ Cracked ☐ Root Intrusion ☒ **Loose Brick** ☐ Deteriorated

frame adj

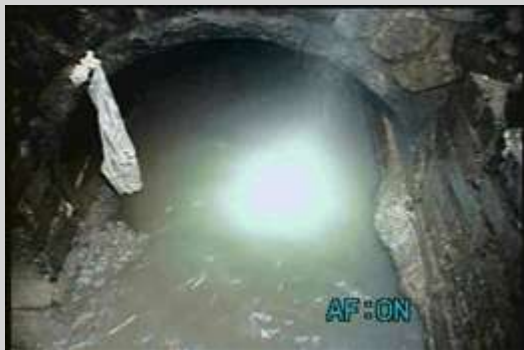
12 O'Clock Outflow

24 in. Circular Gravity Sewer  
Pipe Out @ 12 O'Clock

Pipe Material: **Clay** ☐ Pipe Lined

Invert Depth: **15.03** (ft.) Flow Characteristics: **Fast**

Infiltration: **None** Pipe Seal Cond: **Unknown**

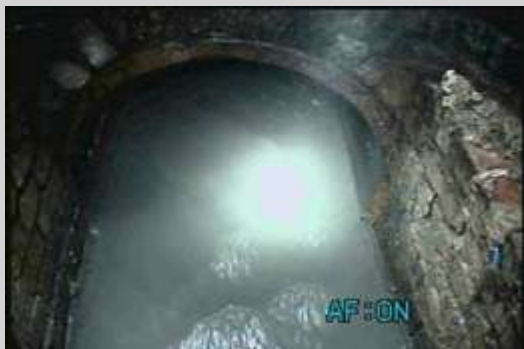
6 O'Clock Inflow

24 in. Circular Gravity Sewer  
Pipe In @ 6 O'Clock

Pipe Material: **Clay** ☐ Pipe Lined

Invert Depth: **14.74** (ft.) Flow Characteristics: **Fast**

Infiltration: **None** Pipe Seal Cond: **Unknown**

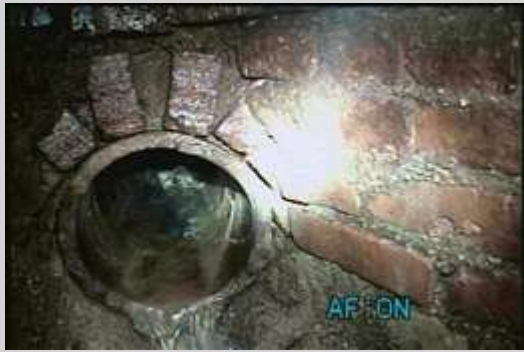
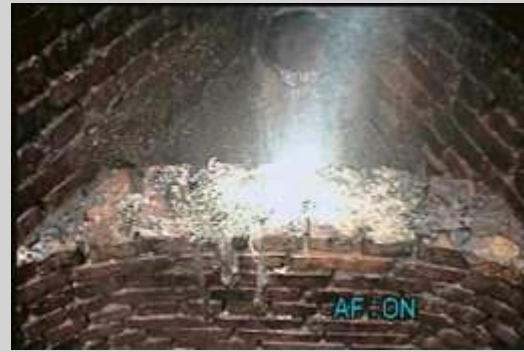
9 O'Clock Inflow

4 in. Circular Gravity Sewer

Pipe Material: Clay ☐ Pipe Lined

Invert Depth: 9.62 (ft.) Flow Characteristics: Slow

Infiltration: None Pipe Seal Cond: Unknown

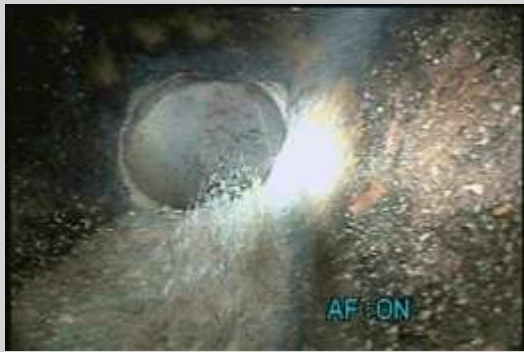
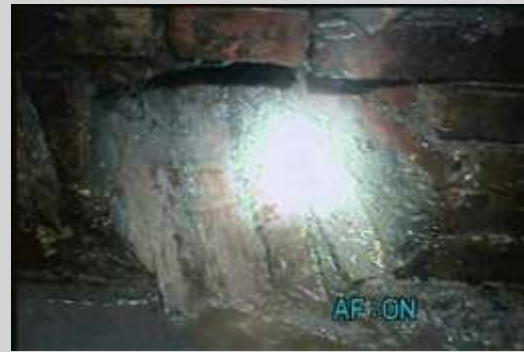
Drop In @ 9 O'Clock

Drop: Inside Direct

Inv Depth: 14.90 (ft.)

Drop Condition: Open
